[Docket No. 2000-SW-55-AD; Amendment 39-12898; AD 2002-20-03]

Airworthiness Directives; Eurocopter France Model AS332C, L, L1, and L2; AS350B, BA, B1, B2, B3, and D; AS355E, F, F1, F2, and N; AS-365N2; AS 365 N3; SA330F, G, and J; SA-360C; SA-365C, C1, and C2; SA.316B and C; and SA.319B Helicopters

ACTION: Final rule.

2002-20-03 Eurocopter France: Amendment 39-12898. Docket No. 2000-SW-55-AD.

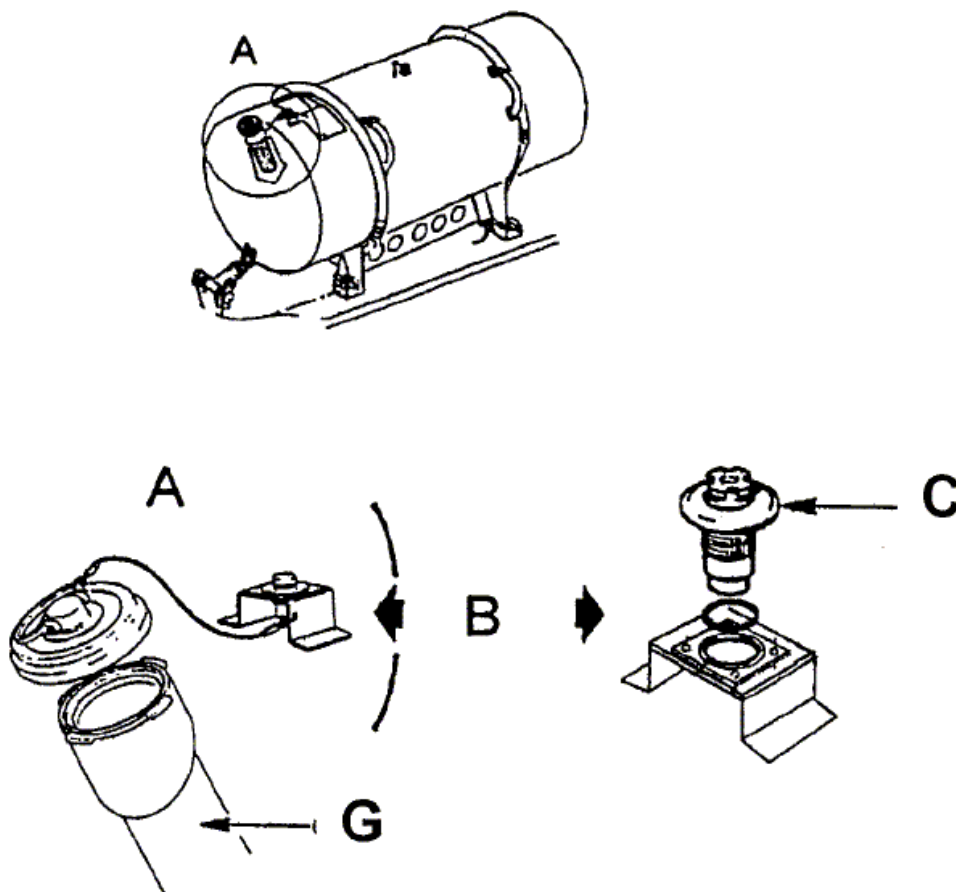
FIGURE 1 FERRY FUEL TANK

To prevent refueling a tank that is not adequately electrically bonded, which could generate an electric arc between the refueling nozzle and the tank, causing a fuel tank explosion, accomplish the following:

(a) Measure the electrical resistance between the tank electrostatic ground connector (item C) and the tank filler neck (item G) as shown in Figure 1 of this AD. If the value of the electrical resistance is more than 1.5 milliohms, refueling the tank is prohibited. See Figure 1 as follows:
